CHANGES IN RIPARIAN VEGETATION IN THE SOUTHWESTERN UNITED STATES: Floods and Riparian Vegetation on the San Juan River, Southeastern Utah

USGS OPEN FILE REPORT OF 01-314

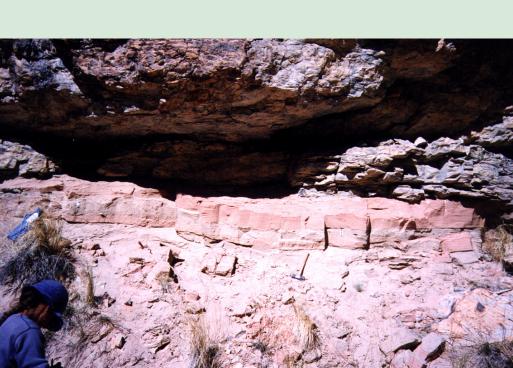
neath a bedrock overhang. This particular deposit is at river mile 15.1 on river right and contains 6 flood units.

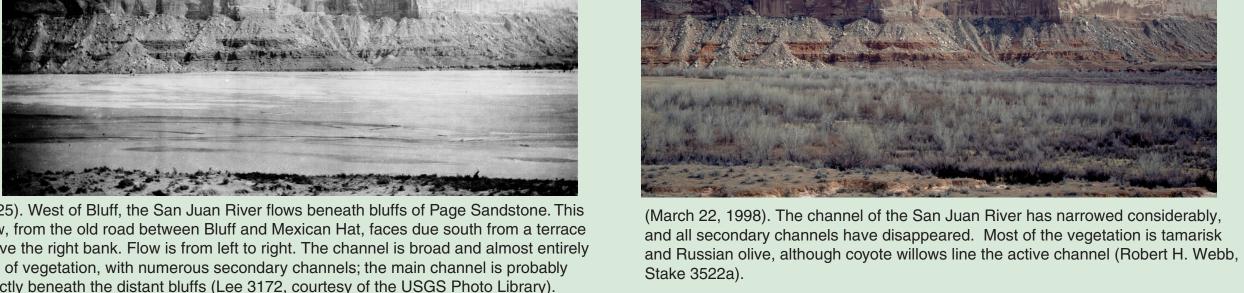
was taken just before the 1909 flood (Stuart Malcolm Young NAU.PH.643.1.2)

courtesy of Northern Arizona University Cline Library).

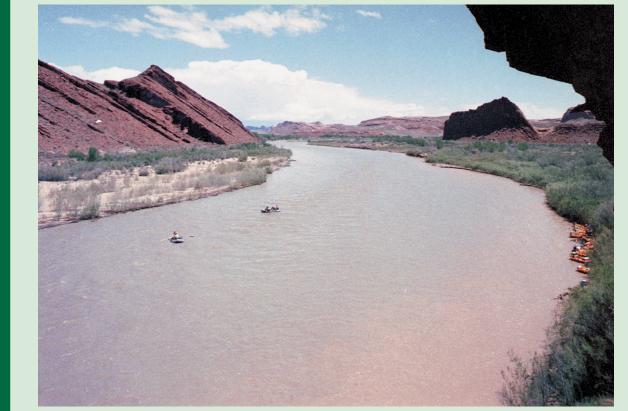
and the San Juan River, shows the small boats of a commercial river trip. The river (Bill Belknap NAU.PH.96.4.318.8, courtesy of the Northern Arizona University Cline

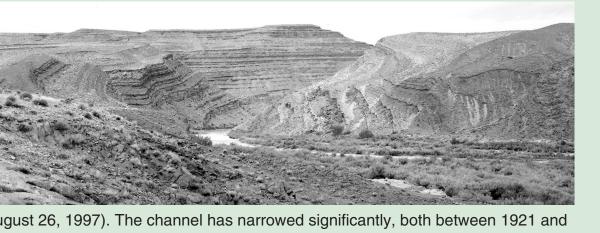
since the 1985 photograph. Much of the increase is in non-native tamarisk, but cottonwood trees on both sides of the river have also increased in size. The gravel bar exposed on river left (right center) is not new but merely exposed in the low discharge of 23 m³/s (822 ft³/s) of this view (Dominic Oldershaw, Stake 3933).

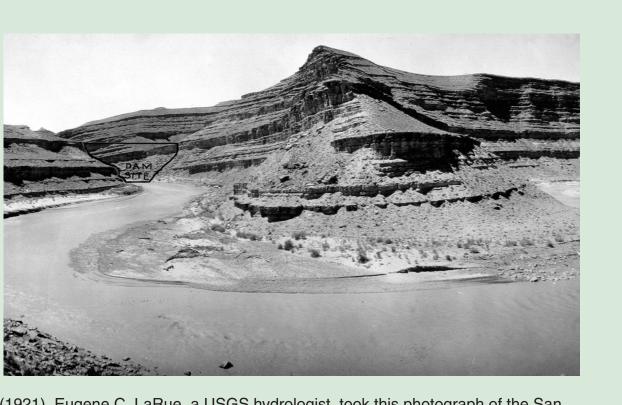
Juan River about 3 km (2 mi) downstream from the entrance to the canyon to document a potential damsite. This upstream view, which is the left center cropped from LaRue's wider view, shows the dam hand drawn on the photograph. Very little riparian vegetation is present in this reach, and the pointbar across the river appears scoured (Eugene C. LaRue 827, courtesy of the USGS Photo Library).

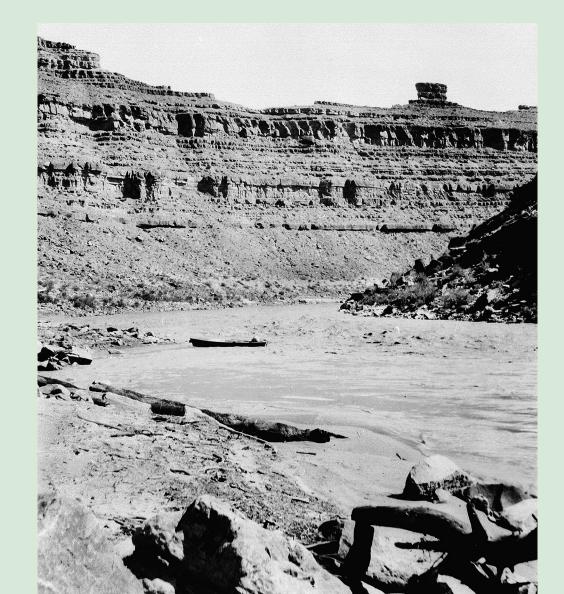
this upstream view of 4-Foot Rapid. Very little riparian vegetation is visible, and what is present are low-statured shrubs. A clear high-water mark appears in the middle distance, probably as a result of the 1911 and other floods (Hugh D. Miser 418, courtesy of the USGS Photo Library).

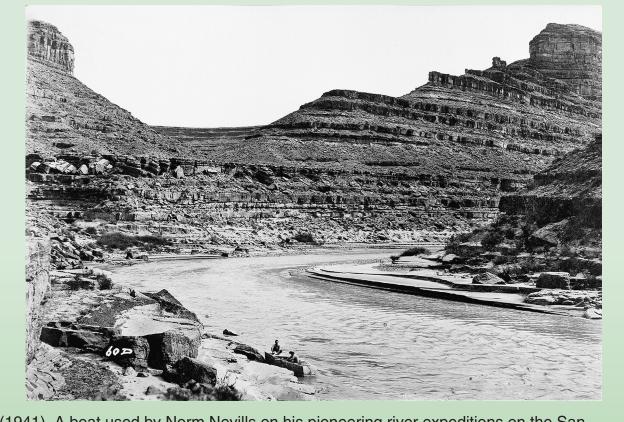
Juan appears in this upstream view from the start of our study reach. Scattered stands hackberry (Celtis reticulata), a small, native tree. This view does not show a significant change in density or cover of riparian vegetation in comparison with other photographs taken between 1875 and 1921 (Phillip W. Tompkins PO341:7:14:5, courtesy of the University of Utah Marriott Library).

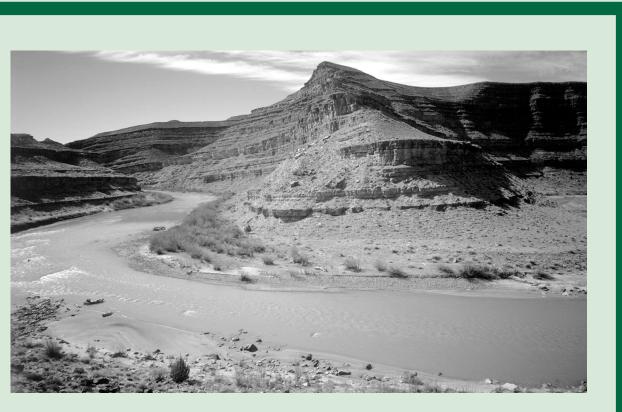
pourovers marks the first rapid of note in San Juan Canyon. The formerly denuded point bar is covered with riparian vegetation, much of which is non-native tamarisk (Dominic Oldershaw, Stake 3560a).

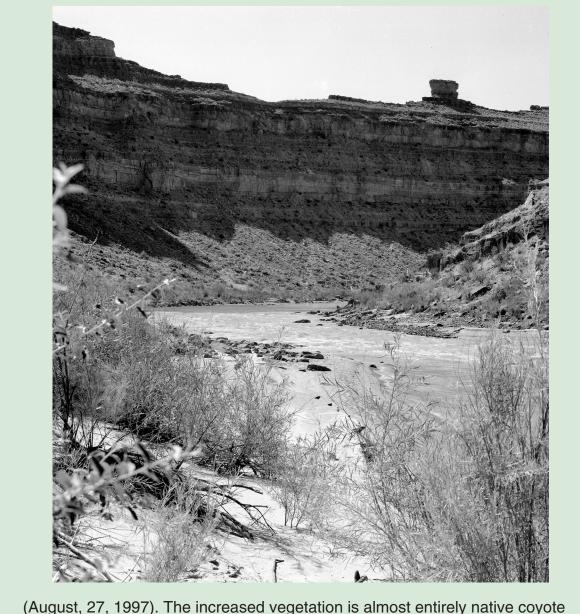
willow, but a distinctive branch of a solitary Russian olive appears at the left. Tamarisk has become established on both sides of the channel in the middle distance. Despite the substantial channel narrowing several miles upstream, the channel has not narrowed appreciably here, and the increase in riparian vegetation is not as large as in the alluvial reaches between Bluff and the entrance to the canyon. The light high-water mark has faded, obscured by desert vegetation (Dominic Oldershaw, Stake 2288).

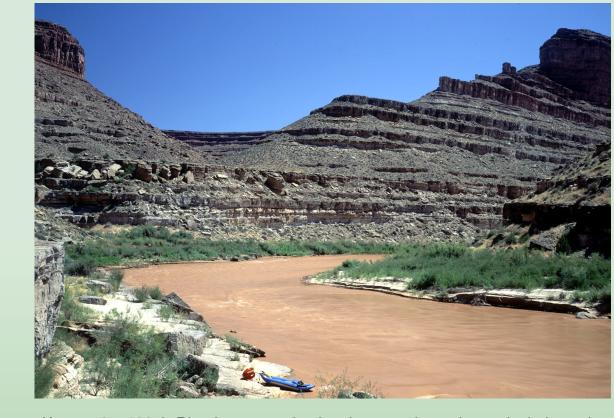
(August 27, 1997). Riparian vegetation has increased greatly, particularly on the point bar at right center. Tamarisk has increased the most, although native species such as coyote willow are also present. A lone juniper appears under the cliff upslope from the point bar (Dominic Oldershaw, Stake 2289).

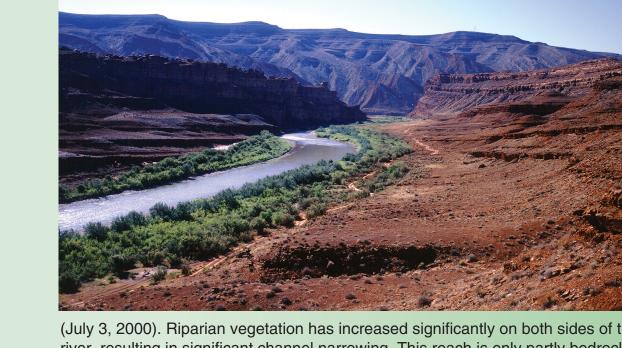
tamarisk just visible behind the willows. Beaver had culled some of the willows

from the sandbar shortly before our visit (Robert H. Webb, Stake 3529).
